Center for Integration
of Composites into
Infrastructure

Industrial Advisory Board (IAB) Meeting

CICI-14

**Prestressed MF-FRP Repair of Deteriorated PC
Bridge Beams**

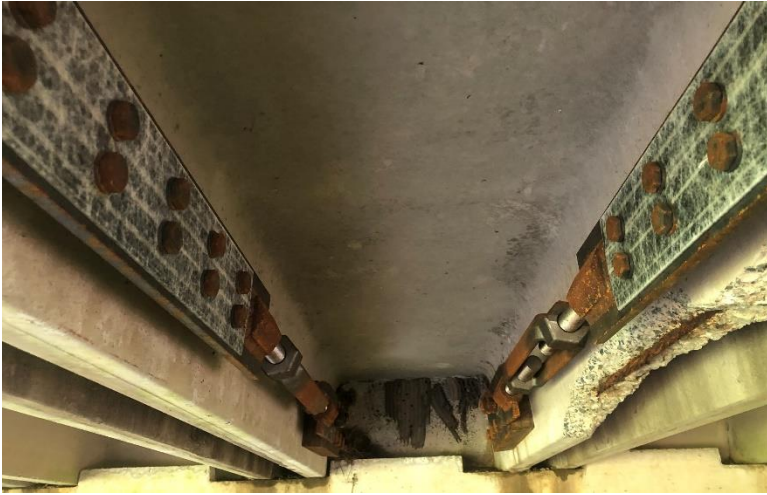
Field Application – Sampson County Bridge

Current Condition

- ▶ Repair installed in November 2020.
- ▶ After 6 months in service
 - Retrofit remains in good condition

- ▶ Built in 1966
- ▶ 3-spans, C-channel Beam
- ▶ Current status: Open for service
- ▶ Load Posting: 16/22

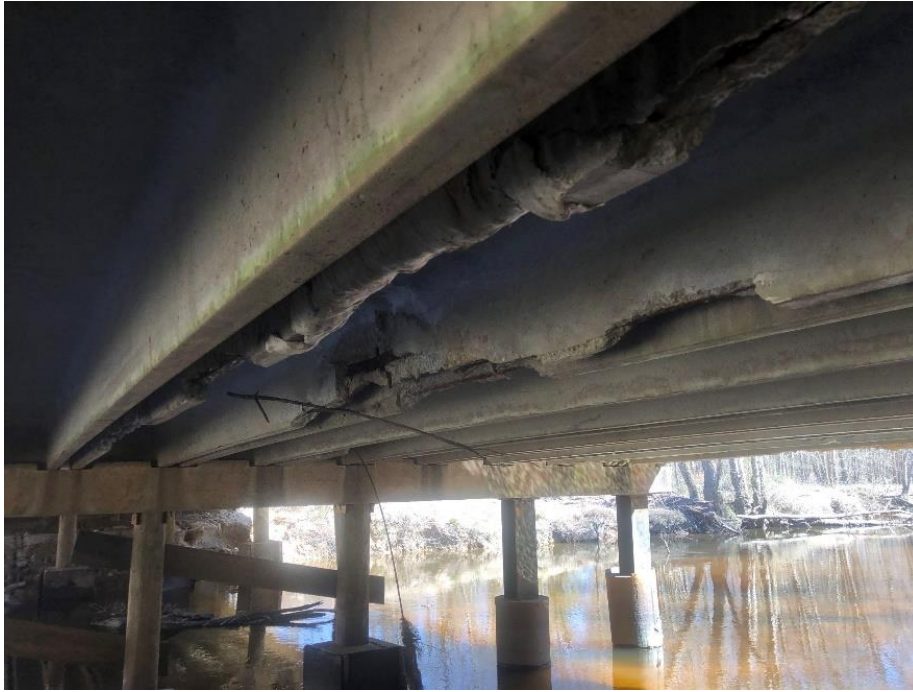
Field Application – Wake County Bridge

- ▶ Built in 1967
- ▶ 3-spans, C-channel Beam
- ▶ Current status: Open
- ▶ Load Posting: 5/0

- ▶ Plan to repair three stems with loss of bottom prestressing strand.

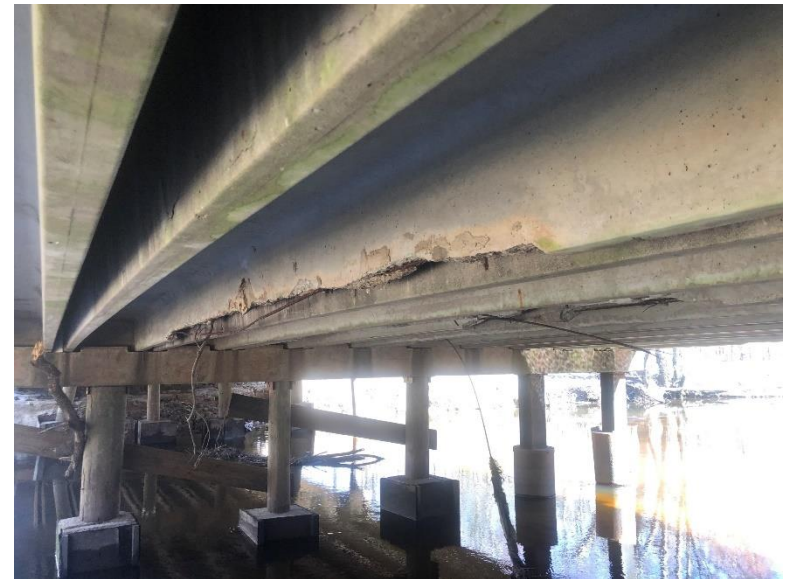
Shear Deteriorated C-channel Beam

- ▶ Concrete spalled
- ▶ Prestressing strand corroded
- ▶ Shear capacity concern

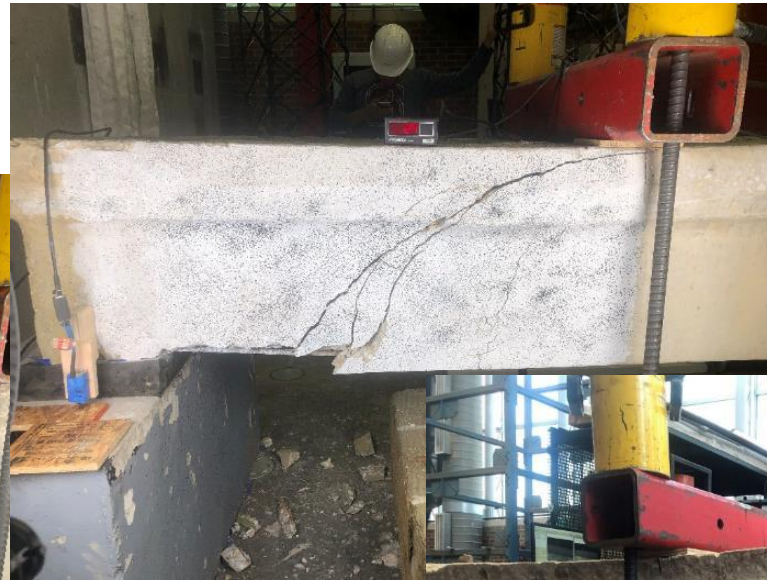
Intermediate Damage: 49.2 kips

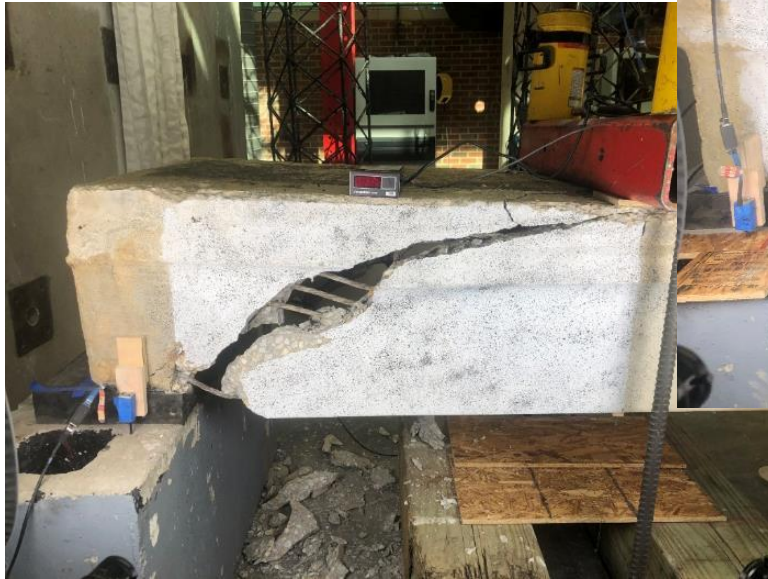
Undamaged: 51.8 kips

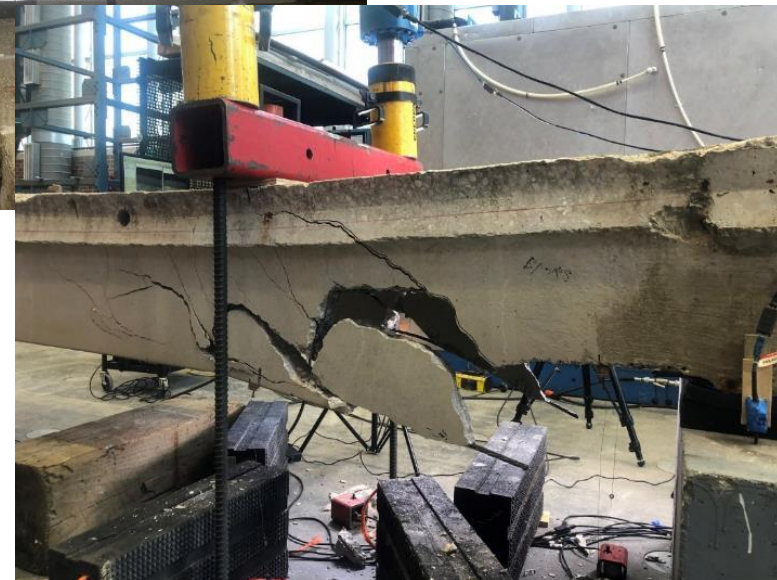
Severe Damage: 38.7 kips

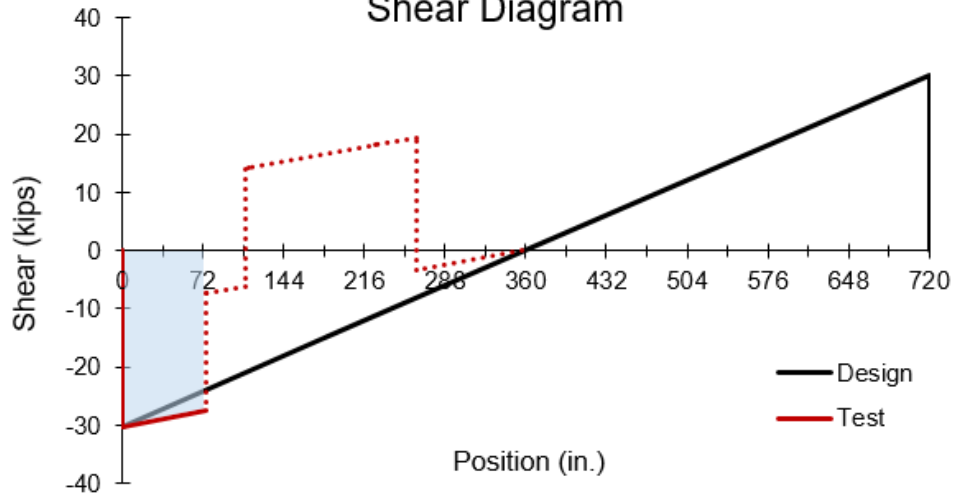
Shear Diagram

$P = 20.2$ kips
 Dead Load = 83.9 psf
